Landusky Mine Reclamation Progress

- **Reclamation Includes:**
 - Backfilling
 - Regrading/Lime Amendment
 - Barrier Placement
 - Soil Placement
 - Revegetation
 - Maintenance
- **Some Reclamation done by ZMI prior to 1998**
- **Interim Reclamation began in 1999 by DEQ and BLM after site abandonment by ZMI**
- **Over \$ 7 Million in additional reclamation funds provided by BLM and DEQ**

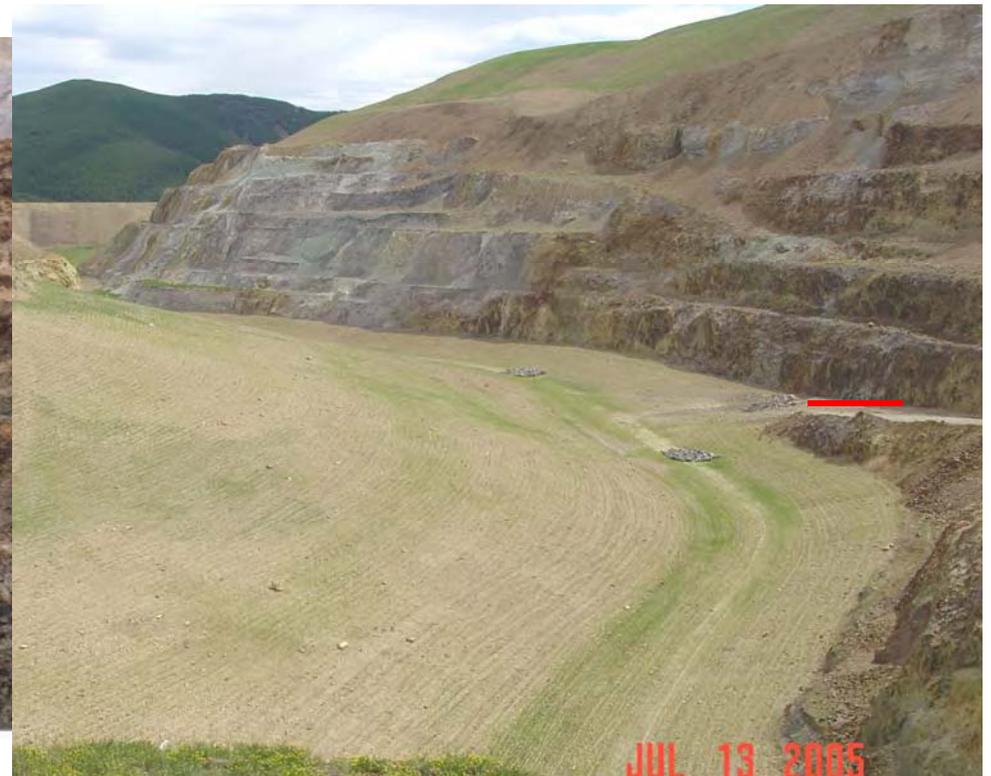
August Pit, October 1999 - Before Draining Pit Lake

August Pit, July 2005 - Reclamation Work Complete

Note: Red line to the right in each photo shows the same pit wall elevation.

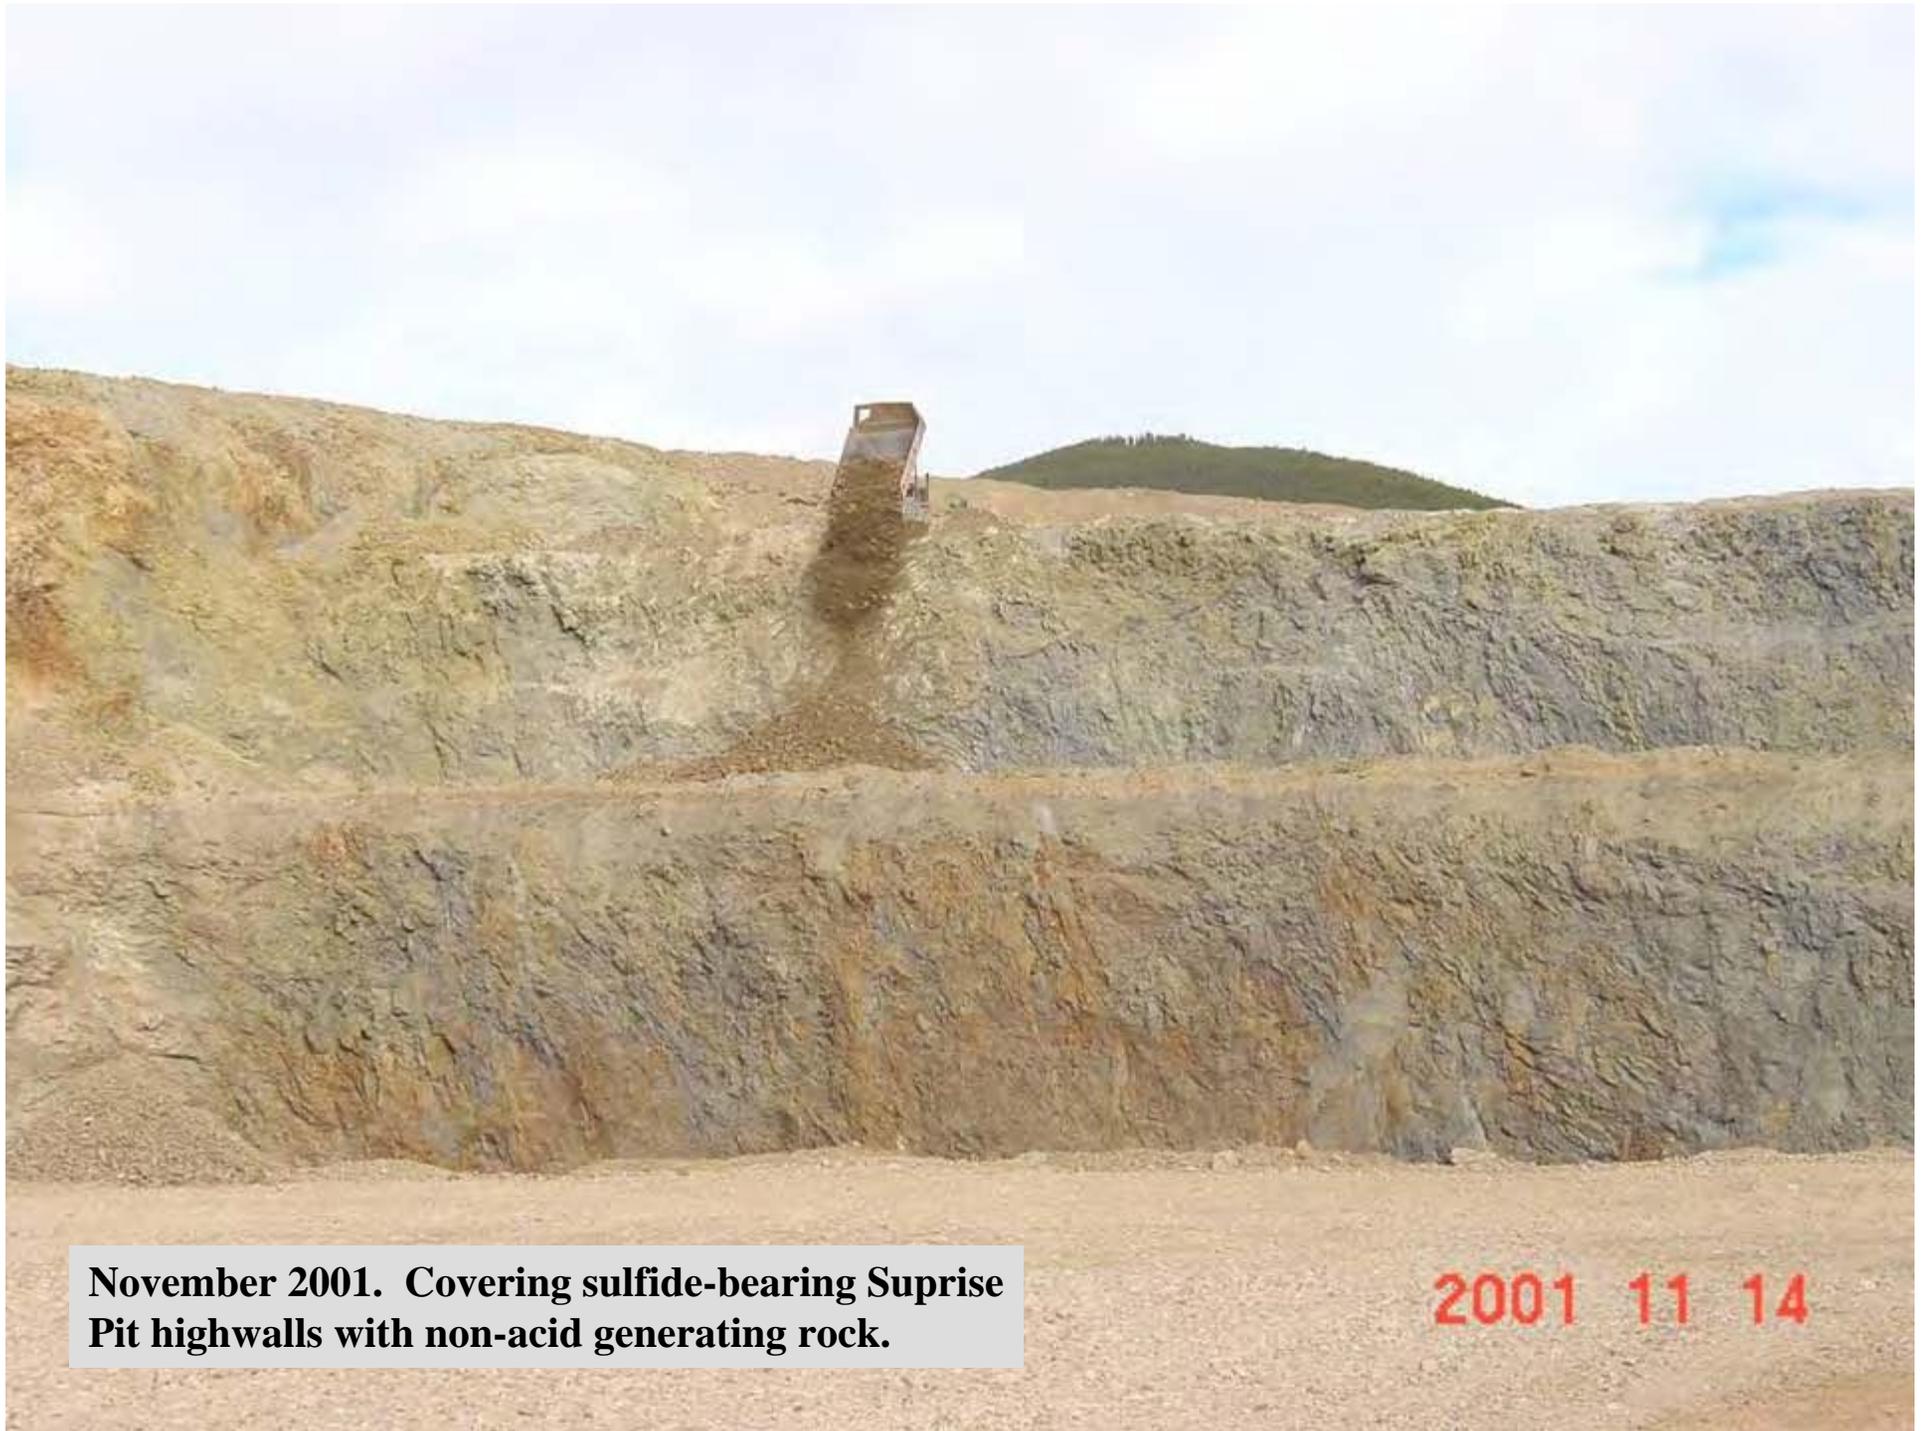
November 2001. Covering sulfide-bearing Surprise Pit highwalls with non-acid generating rock.

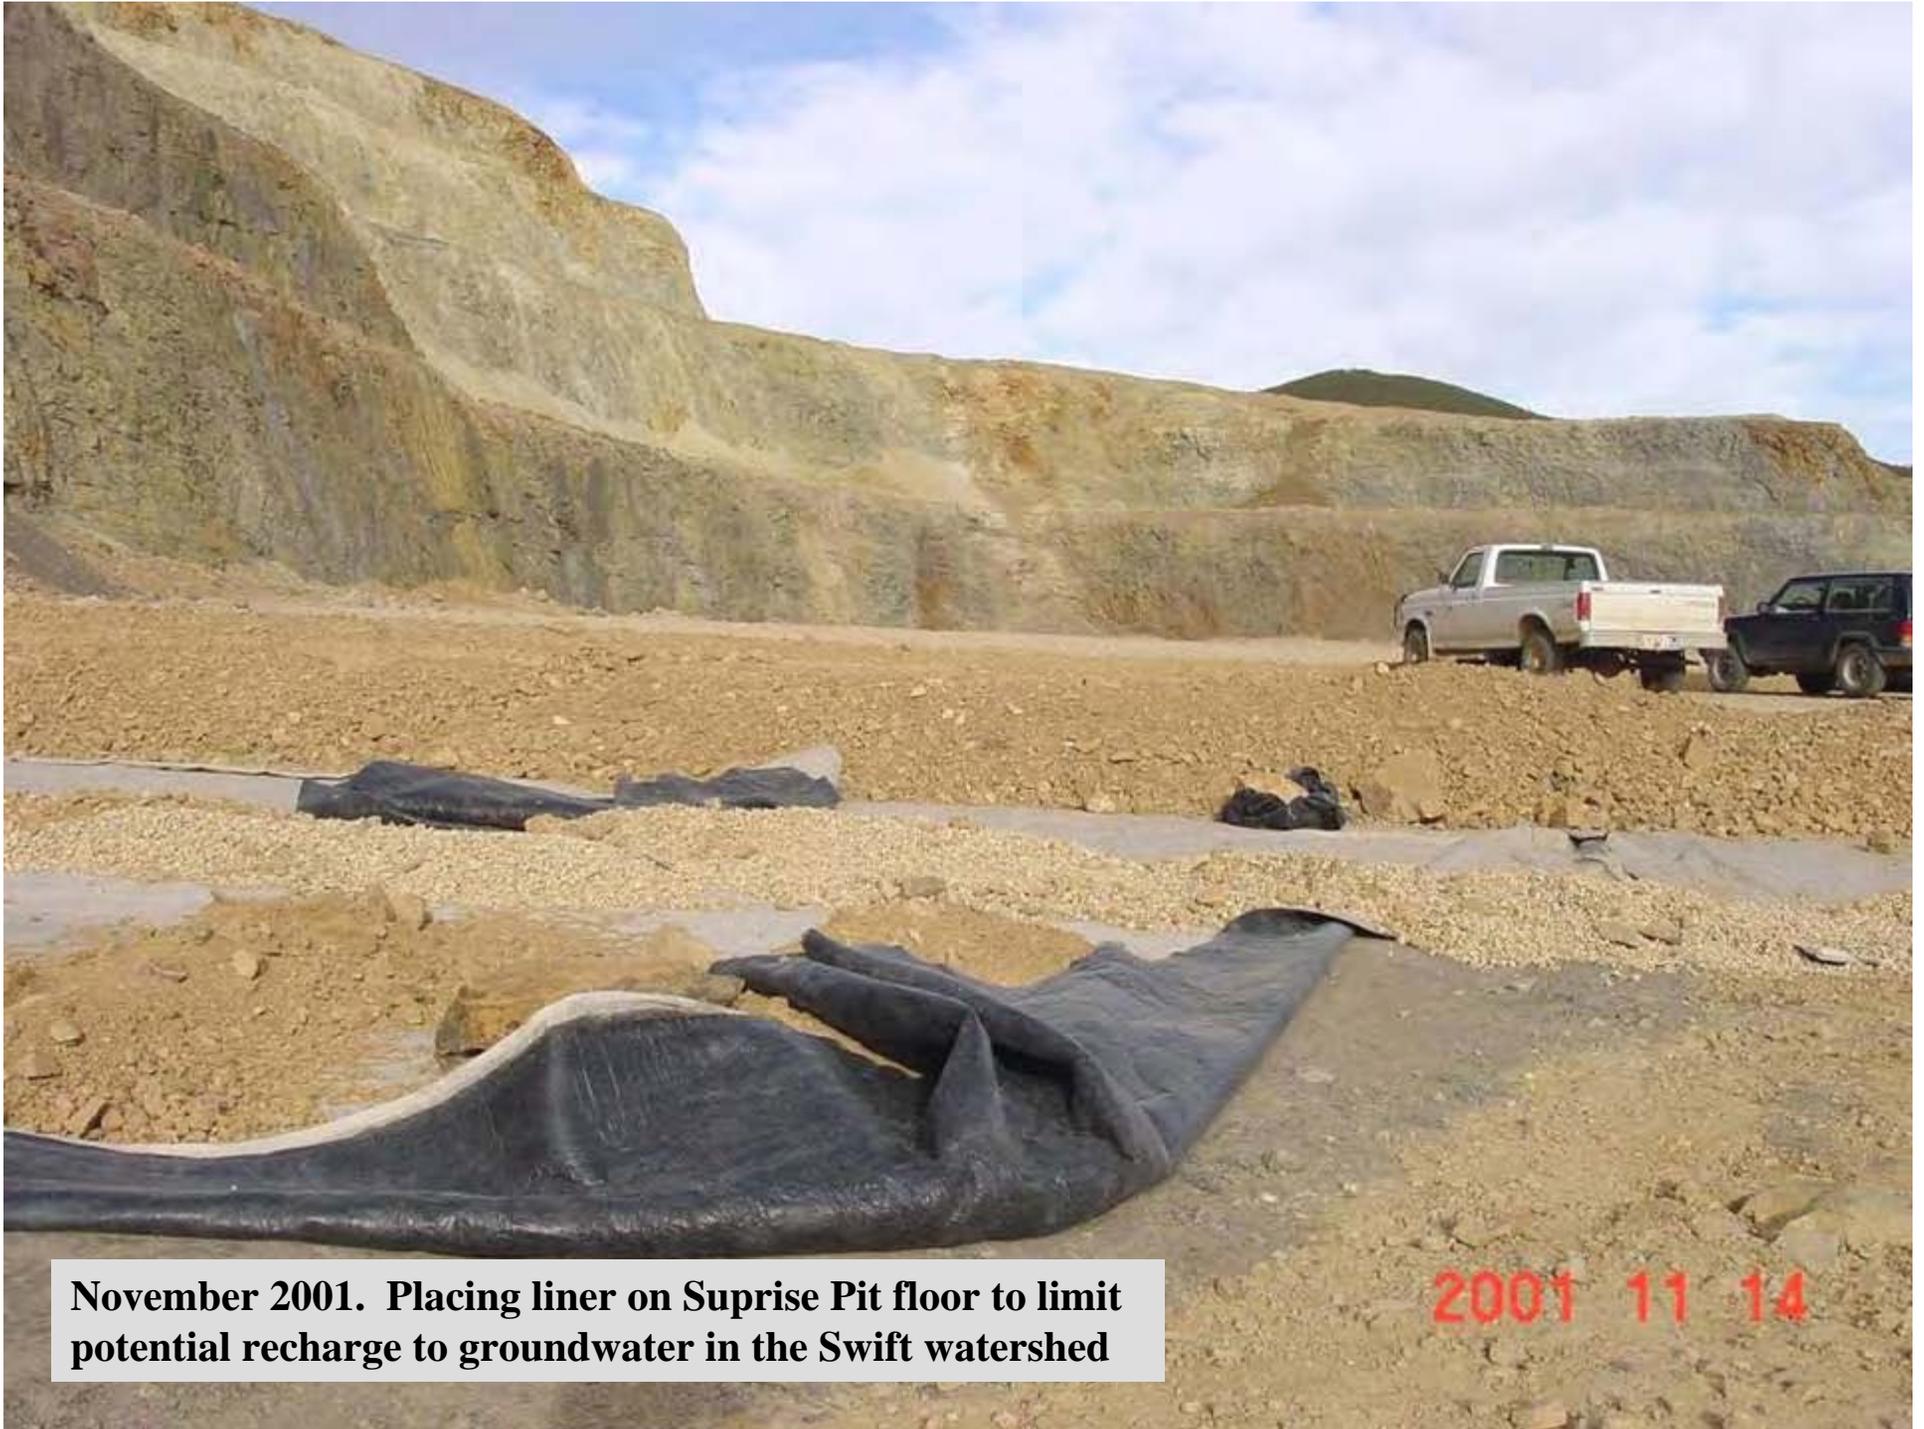
November 2001. Placing liner on Suprise Pit floor to limit potential recharge to groundwater in the Swift watershed

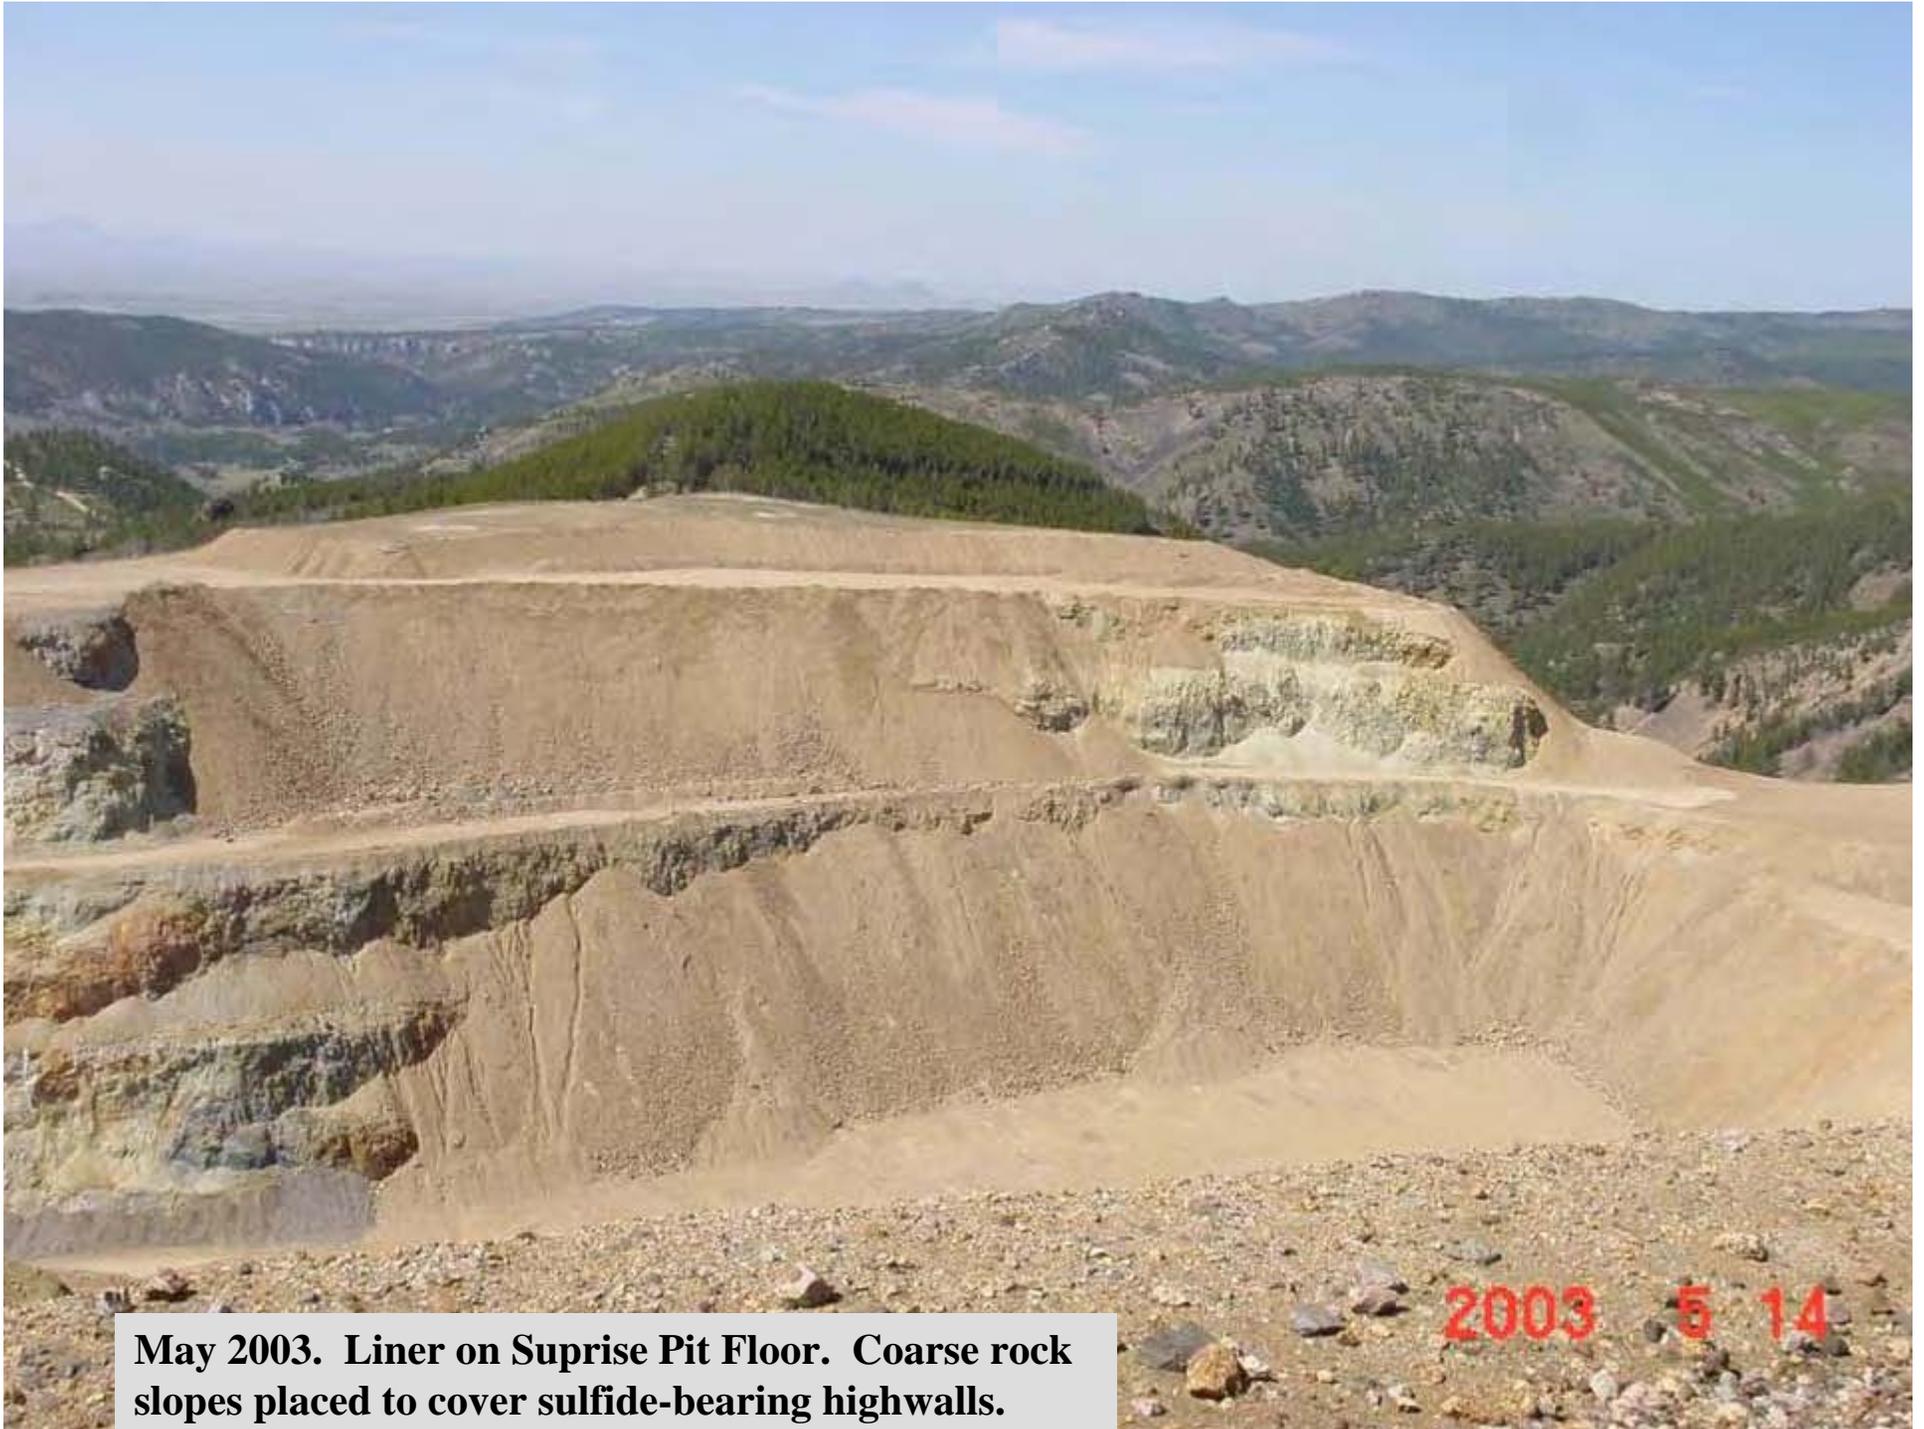
May 2003. Liner on Surprise Pit Floor. Coarse rock slopes placed to cover sulfide-bearing highwalls.

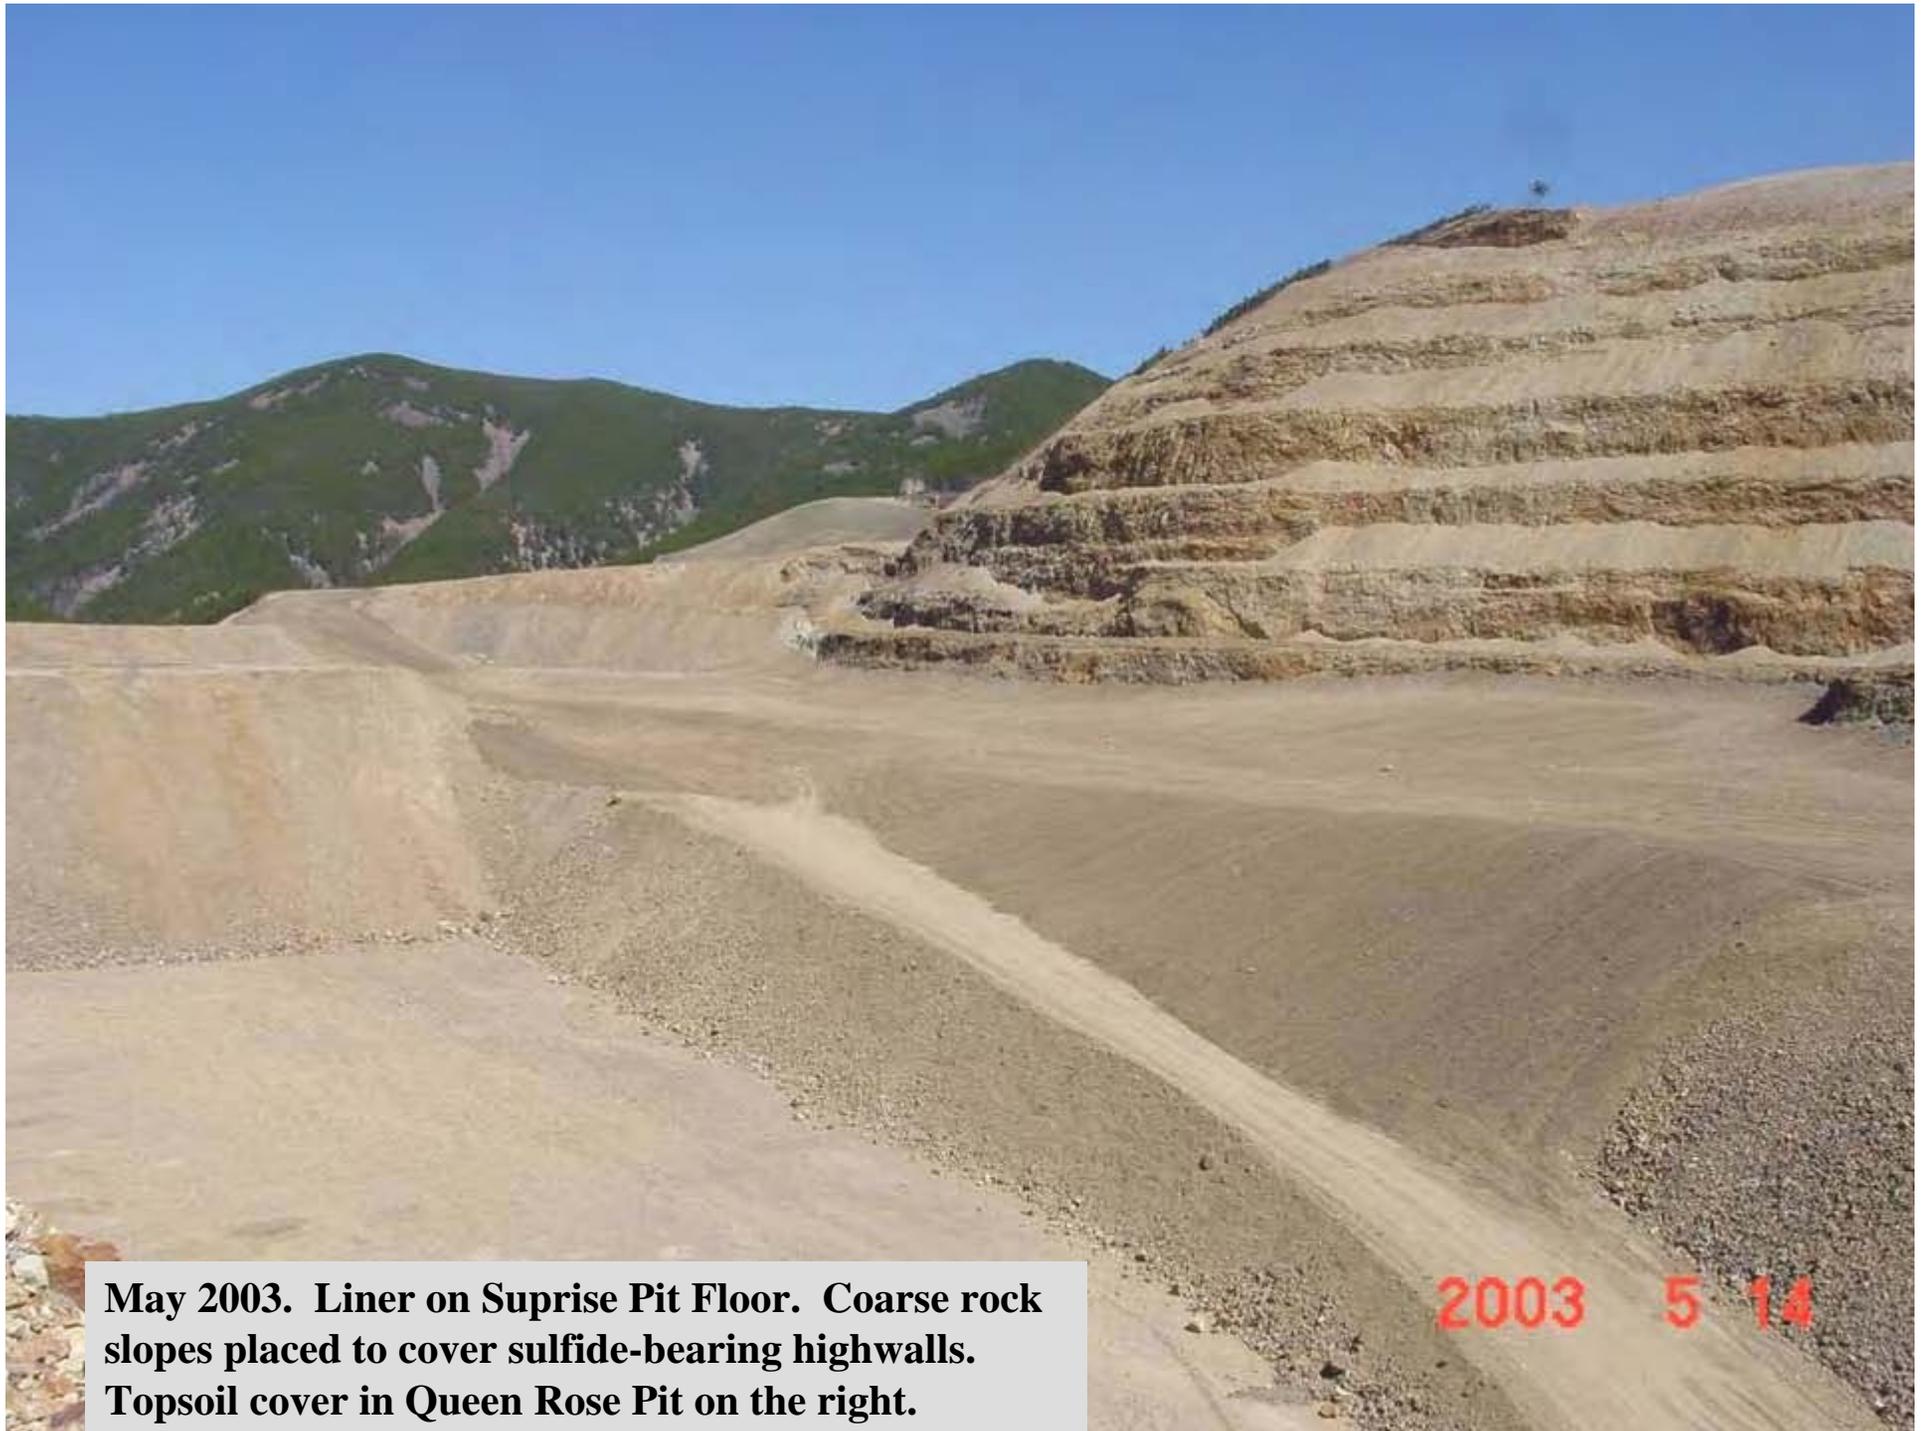
May 2003. Liner on Suprise Pit Floor. Coarse rock slopes placed to cover sulfide-bearing highwalls. Topsoil cover in Queen Rose Pit on the right.

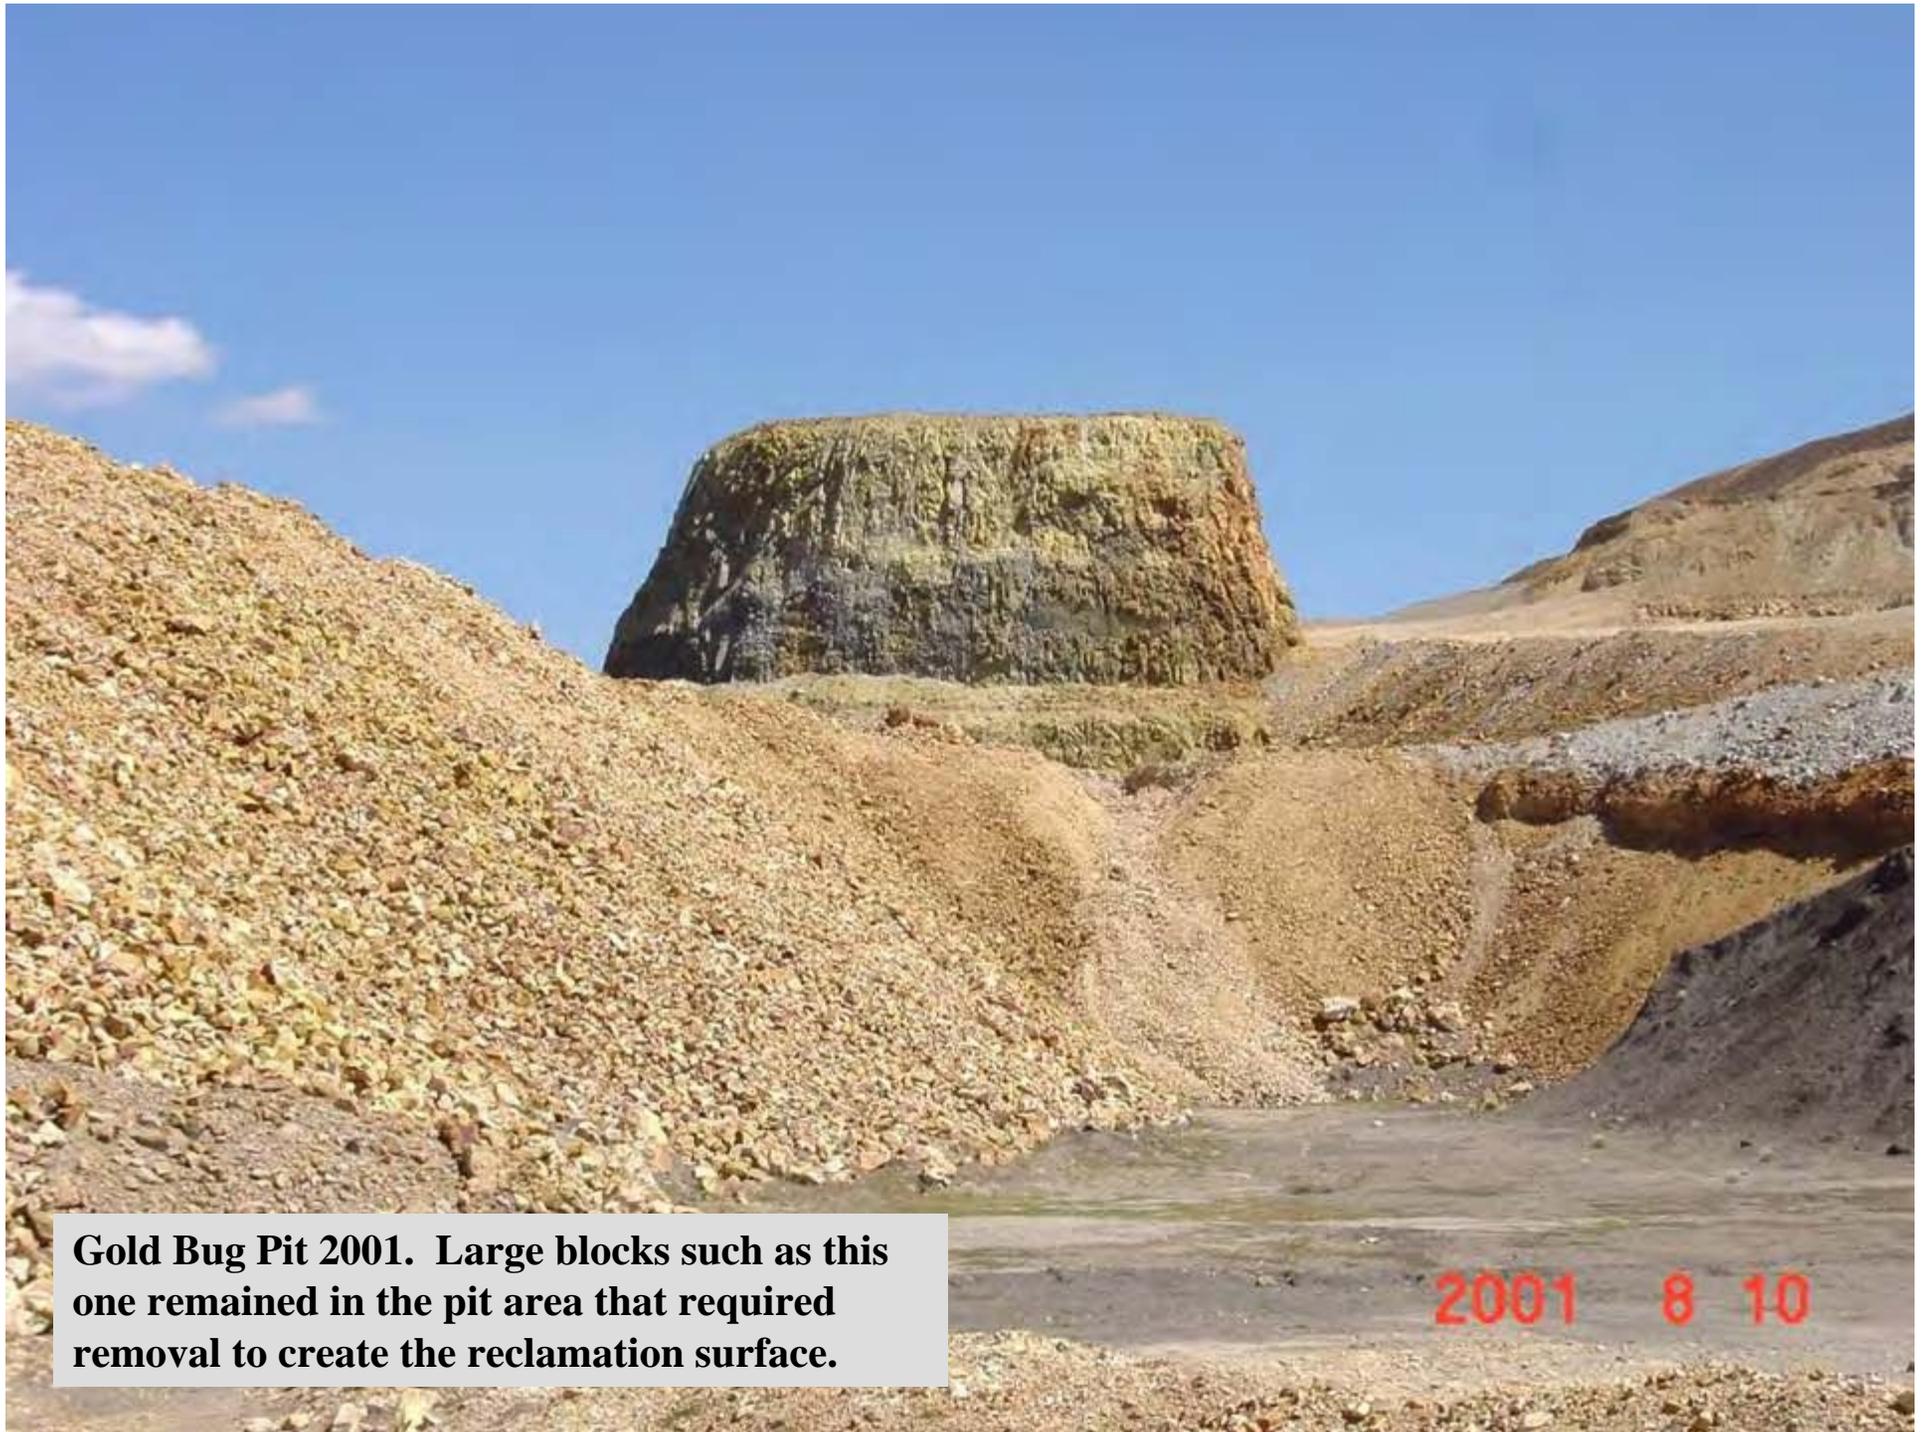
Gold Bug Pit 2001. Large blocks such as this one remained in the pit area that required removal to create the reclamation surface.

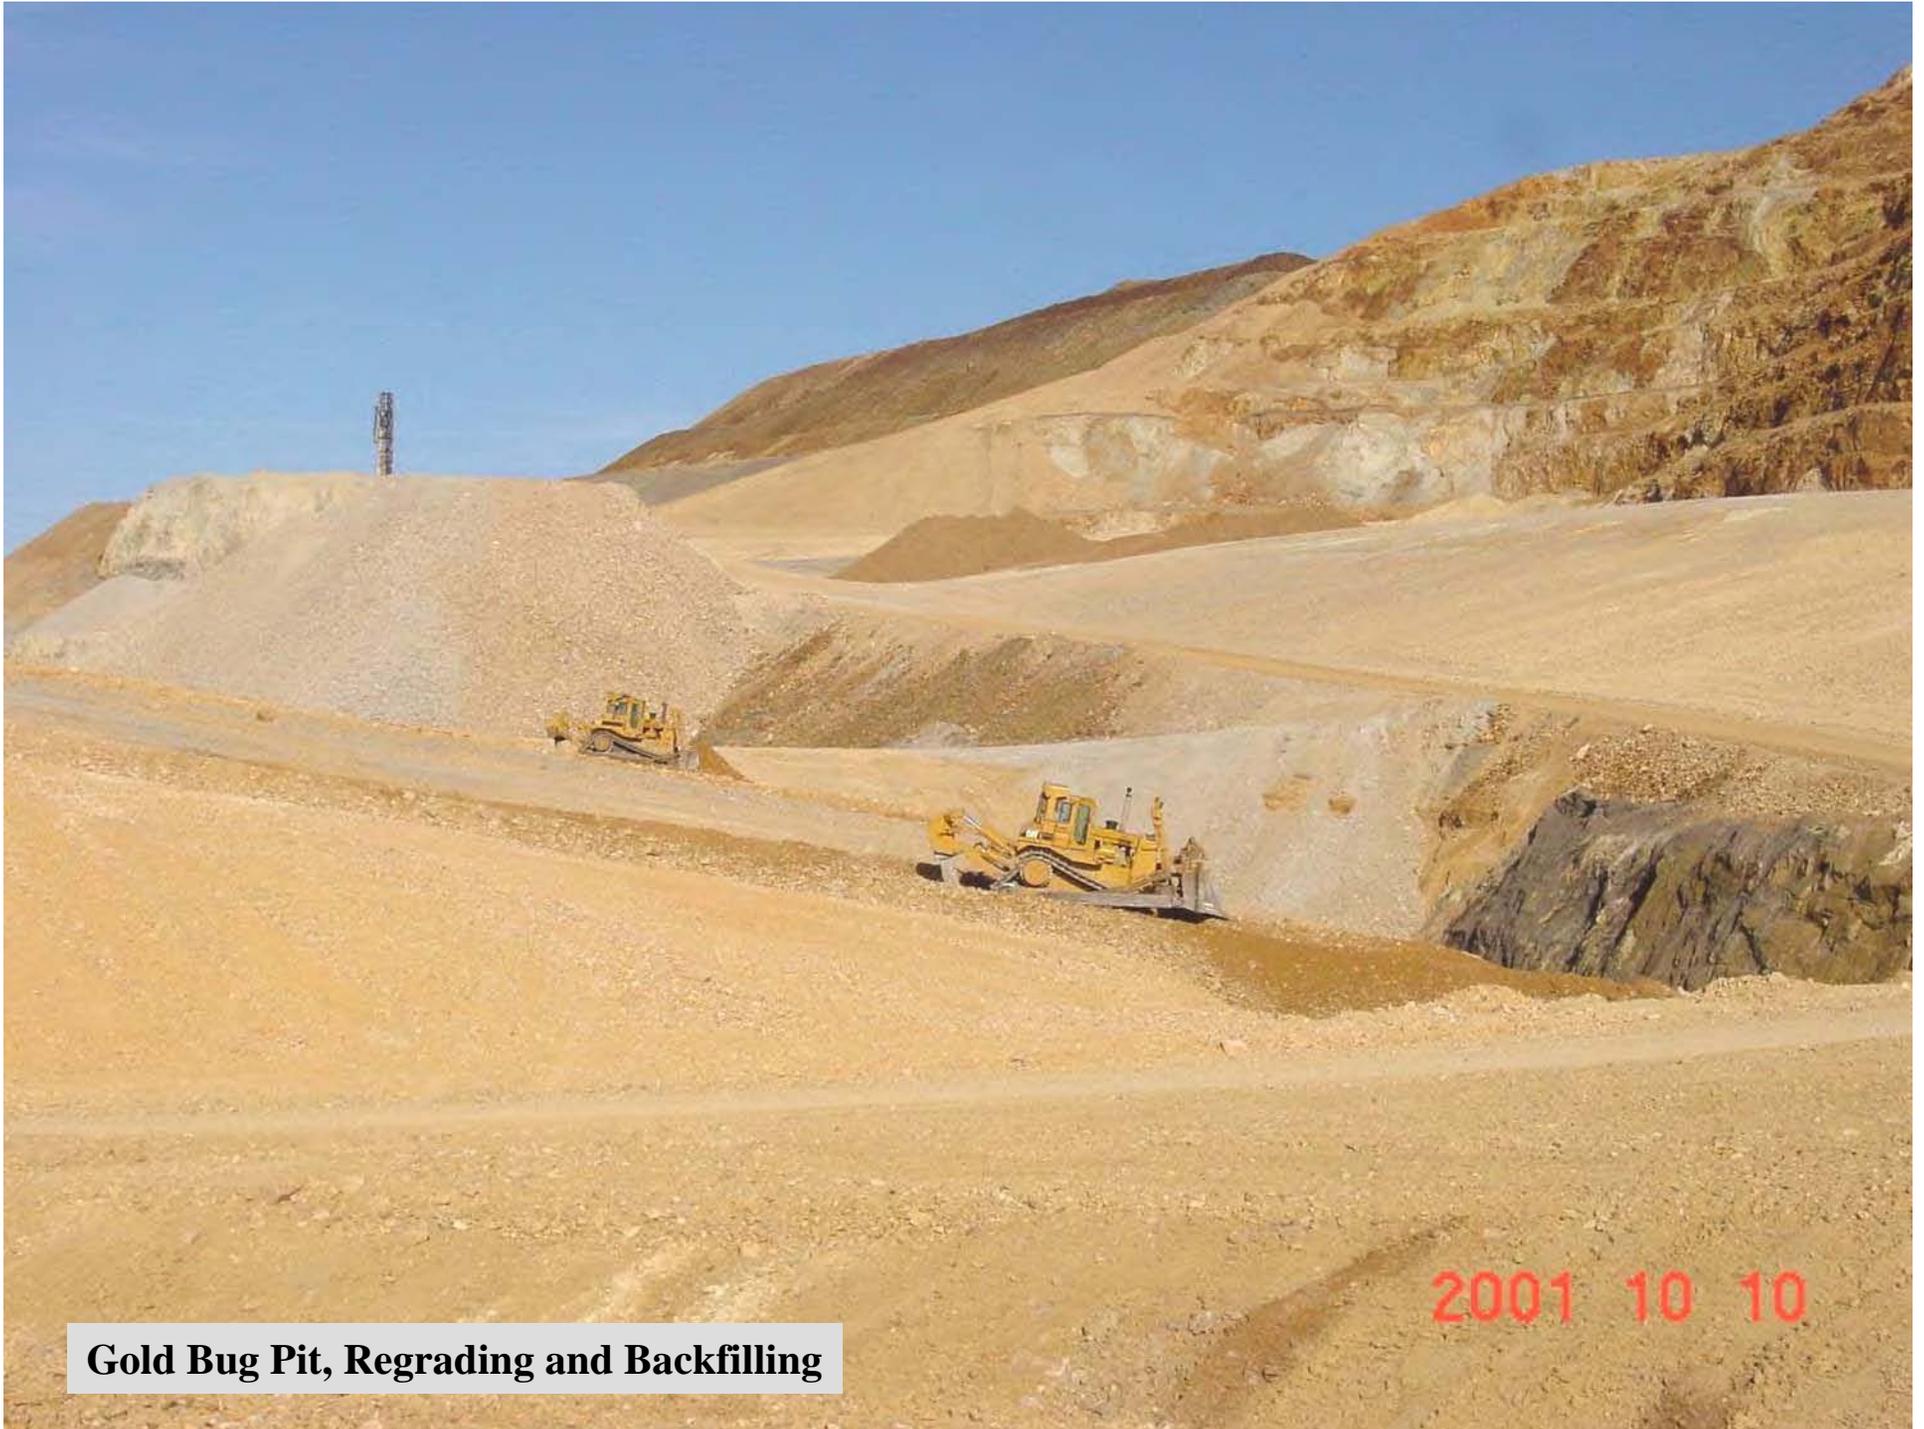
Gold Bug Pit, Regrading and Backfilling

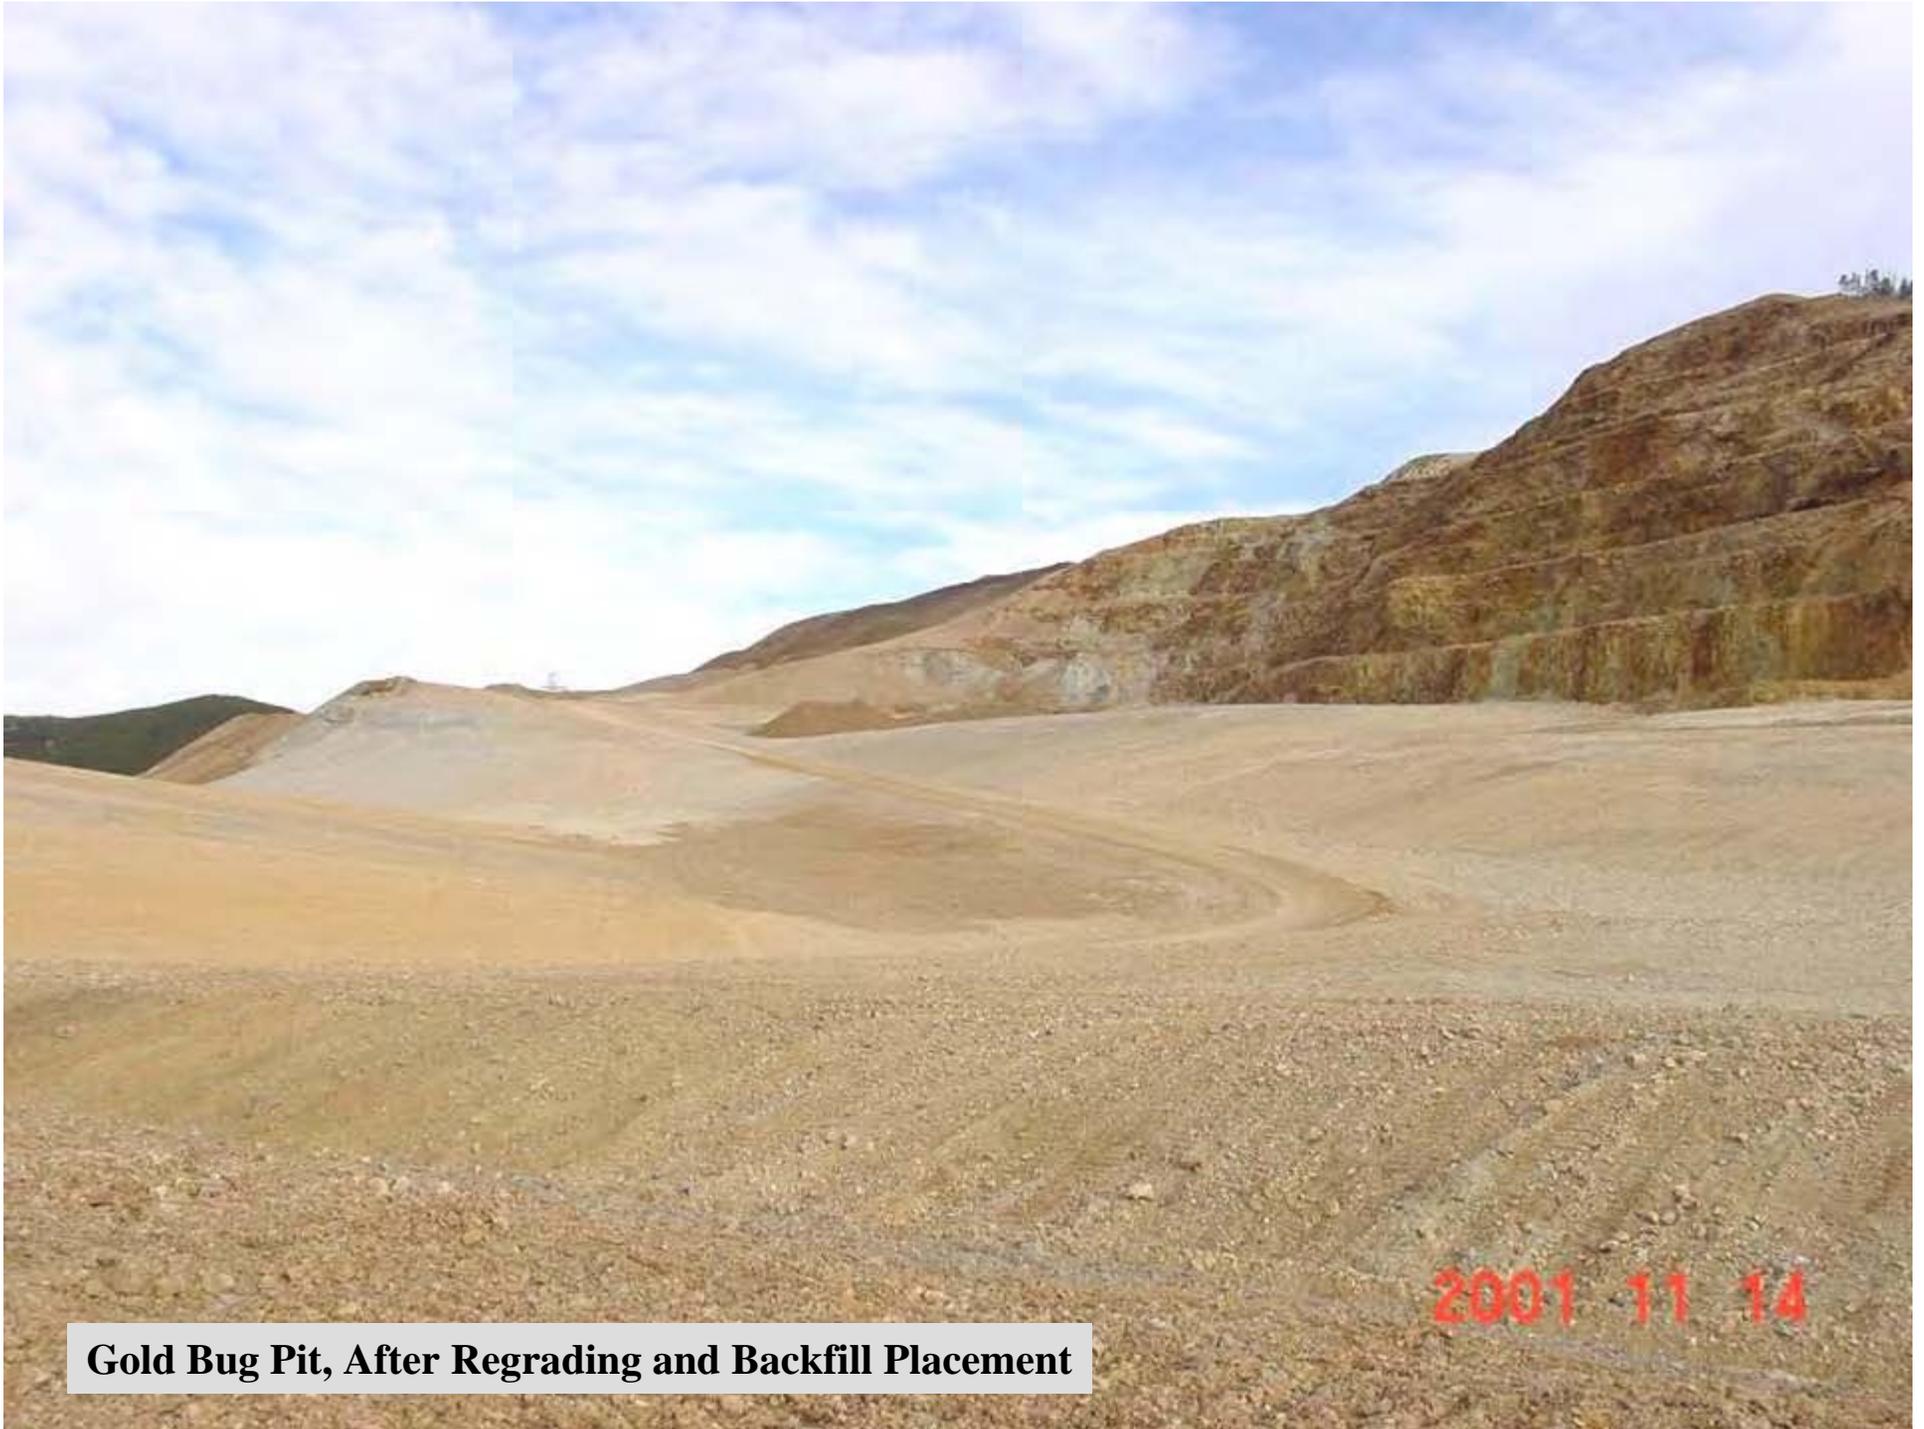
Gold Bug Pit, After Regrading and Backfill Placement

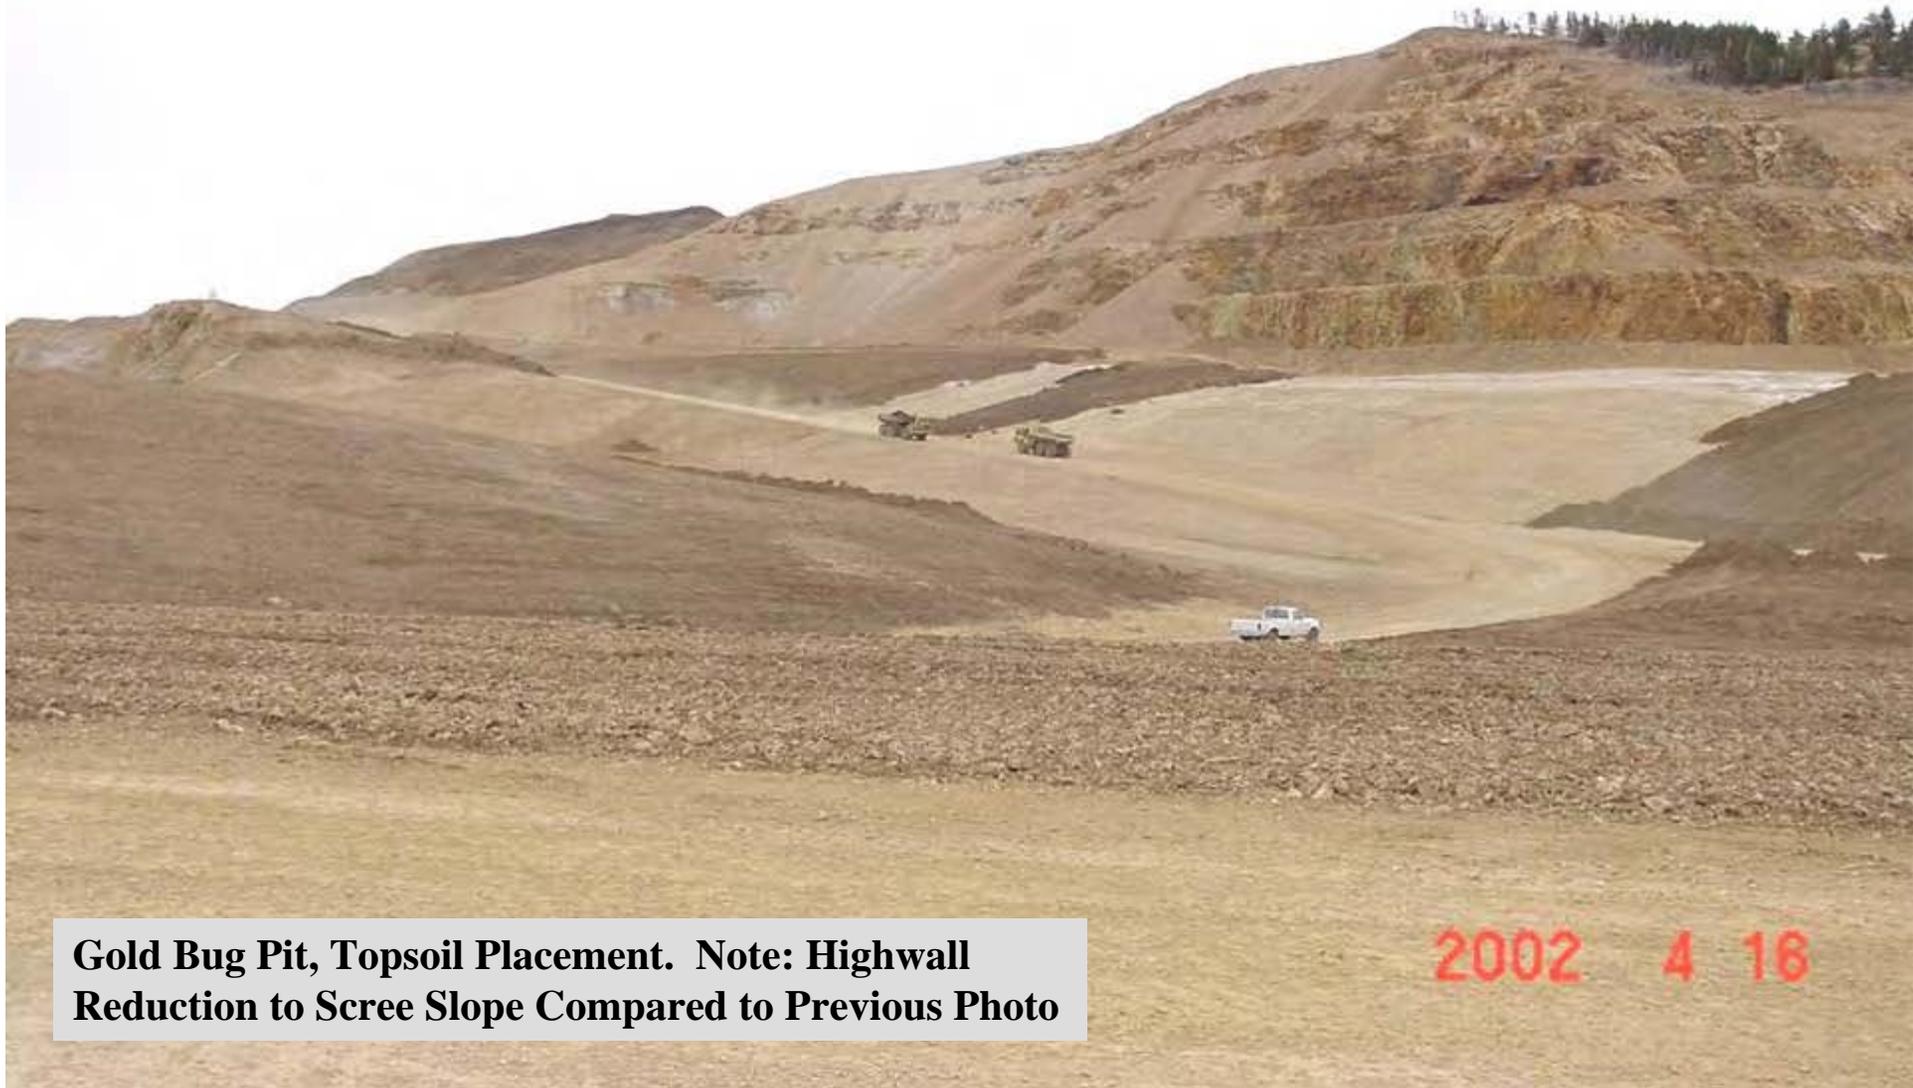
Gold Bug Pit, Topsoil Placement. Note: Highwall Reduction to Scree Slope Compared to Previous Photo
